Manhole Inspection Summary

Manhole # S19I1_018MH

Insp Date: **4/18/08 9:54 AM**

Location Address: **2626 janice av**

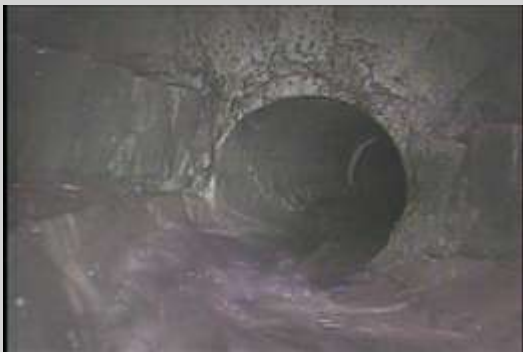
12 O'Clock Outflow

Pipe Height: **8.4** (in.) Rod and Bar (Angled)
Pipe Material: **Clay** ☐ Pipe Lined
Invert Depth: **14.14** (ft.) Flow Characteristics: **Fast**
Deposits: ☒ None ☐ Mud ☐ Sludge ☐ Debris ☐ Grease
Silt Depth: **0** (in.) Deposits Extent:
Infiltration: **None** Pipe Seal Cond: **Sound**

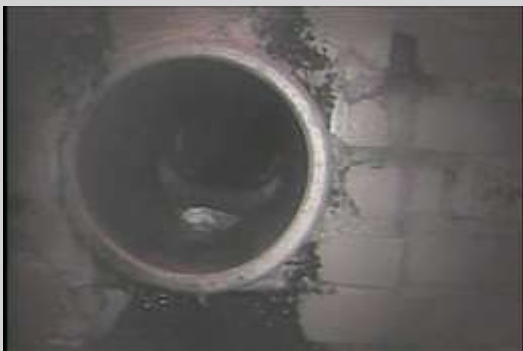
6 O'Clock Inflow

Pipe Height: **8.4** (in.) Rod and Bar (Angled)
Pipe Material: **Clay** ☐ Pipe Lined
Invert Depth: **12.29** (ft.) Flow Characteristics: **Fast**
Deposits: ☒ None ☐ Mud ☐ Sludge ☐ Debris ☐ Grease
Silt Depth: **0** (in.) Deposits Extent:
Infiltration: **None** Pipe Seal Cond: **Unknown**

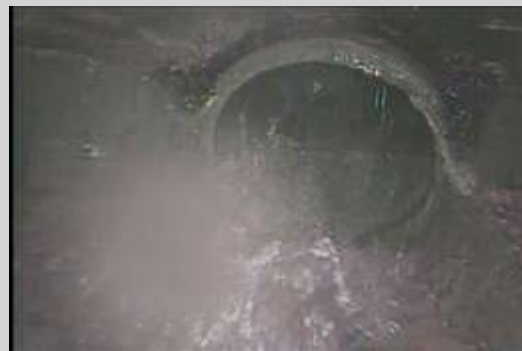
Drop In @ 6 O'Clock

Drop: **Outside** Rod and Bar
Angled: **Yes** Reading: **12.92** (ft.)
Inv Depth: **13.92** (ft.)
Drop Condition: **Open**
